| Product name: | BV Pulsera | |
| Identification code | 0718-094-001 | |

Title: Recycling passport BV Pulsera 0718-094-001
DocID: XDR054-090780

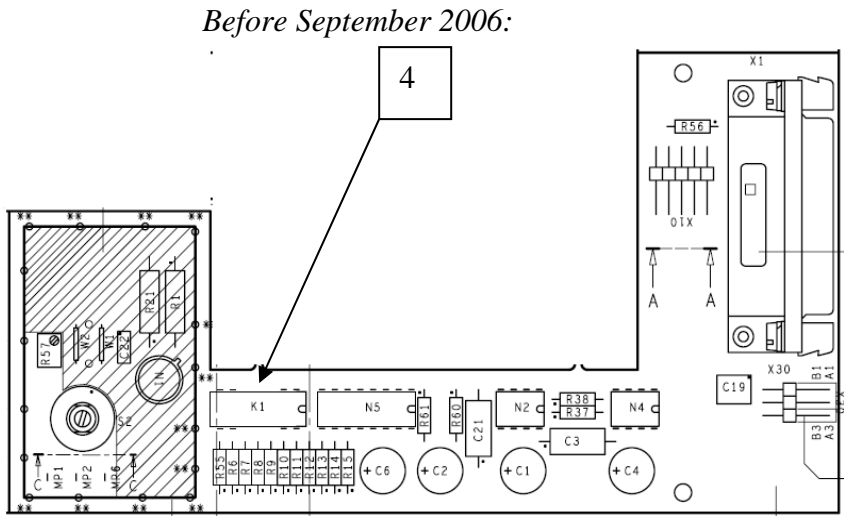
Detail B printed circuit board 4522 167 02431 up and including 4522 167 02439

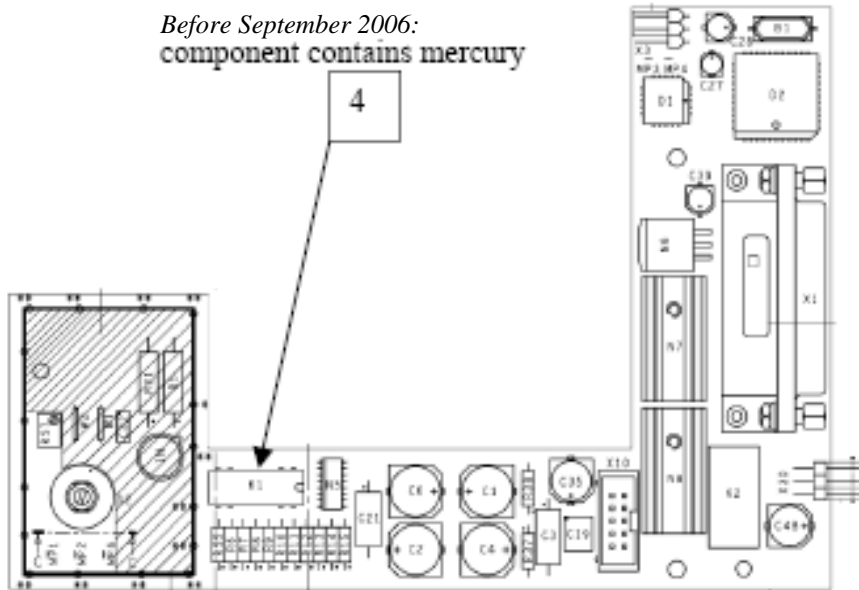
Detail B printed circuit board 4522 167 03471 up and including 4522 167 03475

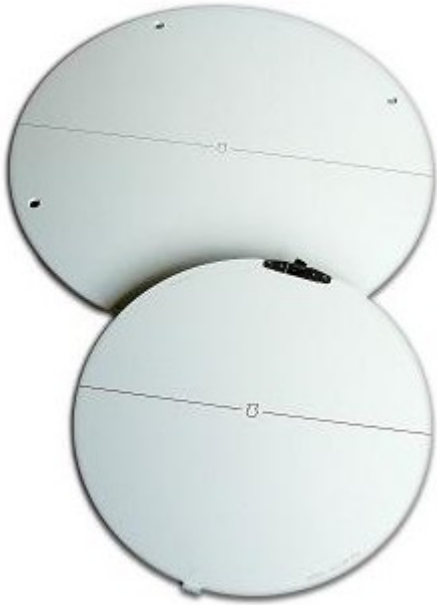
| Hazardous | Substances: | Location |
|---|---|---|
| To be Removed | Lead (Pb 99,5%) | Enclosed between cover plates |

Example larger and smaller grid (only 1 present in system)

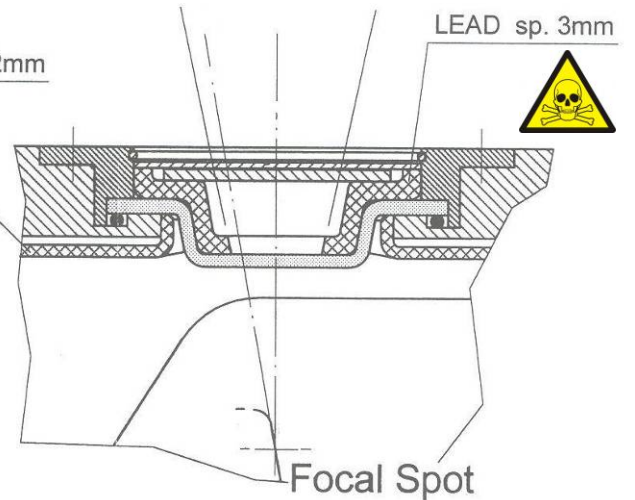
Focal Spot

Detail of X-ray tank

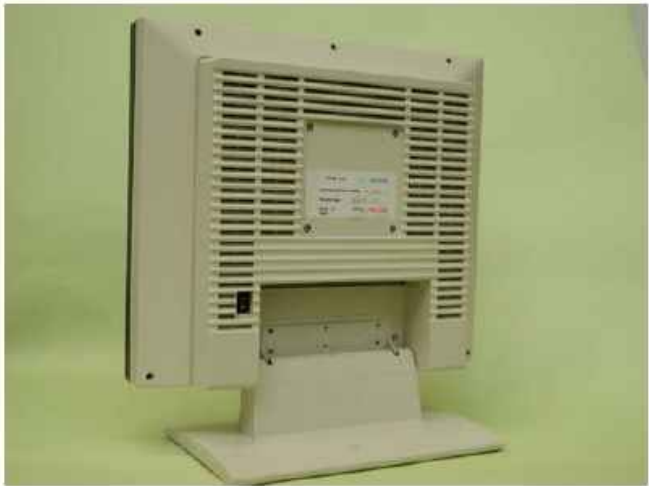
LCD screen FIMI MCL180-L / 9919-320-5089x | PAGE 1 of 2

| Hazardous To be Removed | Substances: | | Location |
|---|--|--|---|
| | Hg | 21 mg max. (*) | Next figure (1) |
| | Pb | Lead is present in the soldering process of PCBs | Next figure (2.x) |
| | (*) Mercury is present in Backlight lamps: 3.5mg x 6 lamps | | |

| Material | | |
|---|--|---|
| Boards (S² > 10cm²) | 96 cm ² / 260 g 320 cm ² / 230 g 144 cm ² / 66 g 72 cm ² / 54 g | S.M.P.S. (item 2.1 in the picture) Logic Board (item 2.2 in the picture) Inverter (item 2.3 in the picture) LCD Driver (item 2.4 in the picture) |

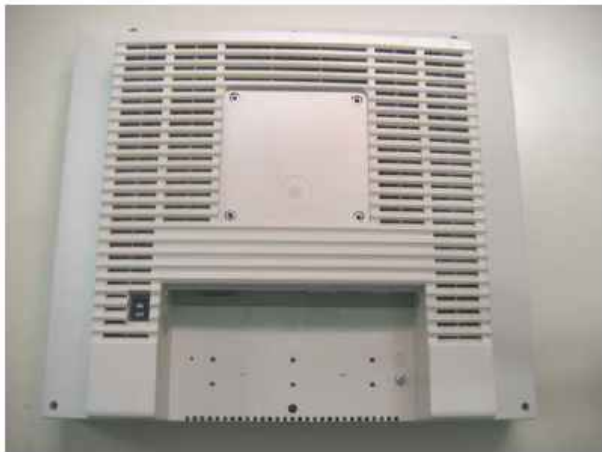
LCD screen FIMI MCL180-HB / 9919-320-5088x

| Hazardous To be Removed | Substances: | | Location |
|---|---|--|---|
| | Hg | 36 mg max. (*) | Figure below (1) |
| | Pb | Lead is present in the soldering process of PCBs | Figure below (2.x) |
| (*) Mercury is present in Backlight lamps: 3mg x 12 lamps | | | |

| Material | | |
|--|---|---|
| Boards (S ² > 10cm ²) | 96 cm ² / 260 g | S.M.P.S. (item 2.1 in the picture) |
| | 320 cm ² / 230 g | Logic Board (item 2.2 in the picture) |
| | 80 cm ² / 180 g | Inverter (item 2.3 in the picture) |
| | 100 cm ² / 50 g | LCD Driver (item 2.4 in the picture) |
| | 46 cm ² / 40 g | PCB Backlight Stabilization (item 2.5 in the picture) |

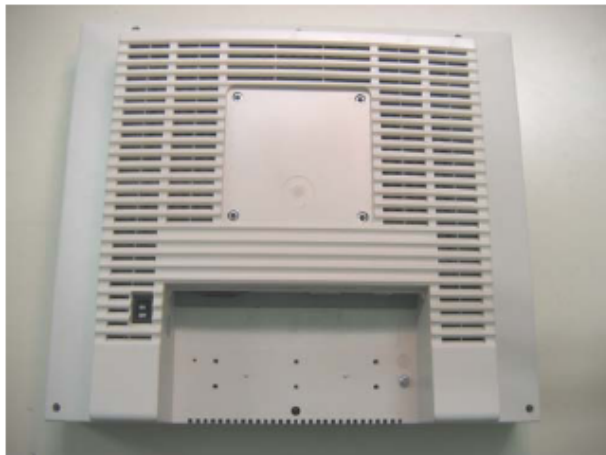
LCD screen FIMI MCL180-LT / 9919-320-5092x

| Hazardous To be Removed | Substances: | | Location |
|---|--|--|---|
| | Hg | 21mg max. (*) | Next figure (1) |
| | Pb | Lead is present in the soldering process of PCBs | Next figure (2.x) |
| | (*) Mercury is present in Backlight lamps: 3.5mg x 6 lamps | | |

| Material | | |
|--|---|---|
| Boards (S ² > 10cm ²) | 96 cm ² / 260 g | S.M.P.S. (item 2.1 in the picture) |
| | 320 cm ² / 230 g | Logic Board (item 2.2 in the picture) |
| | 80 cm ² / 180 g | Inverter (item 2.3 in the picture) |
| | 100 cm ² / 50 g | LCD Driver (item 2.4 in the picture) |
| | 71 cm ² / 80 g | PCB Touch-Screen controller (item 2.5 in the picture) |
| | 40 cm ² / 50 g | PCB Touch-Screen (item 2.6 in the picture) |

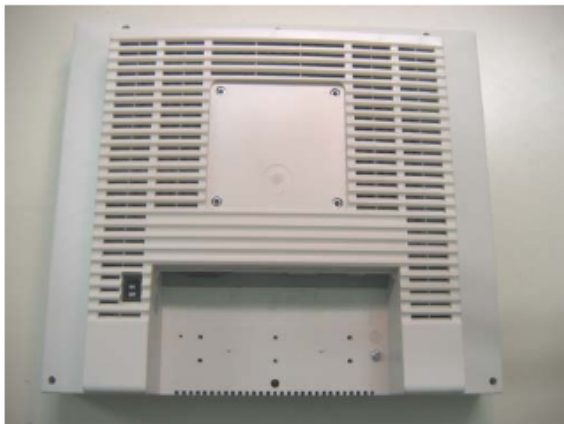
LCD screen FIMI MCL180-HBT / 9919-320-5091x

| Hazardous To be Removed | Substances: | | Location |
|---|--|--|---|
| | Hg | 36 mg max. (*) | Next figure (1) |
| | Pb | Lead is present in the soldering process of PCBs | Next figure (2.x) |
| | (*) Mercury is present in Backlight lamps: 3 mg x 12 lamps | | |

| Material | | |
|--|---|---|
| Boards (S ² > 10cm ²) | 96 cm ² / 260 g | S.M.P.S. (item 2.1 in the picture) |
| | 320 cm ² / 230 g | Logic Board (item 2.2 in the picture) |
| | 80 cm ² / 180 g | Inverter (item 2.3 in the picture) |
| | 100 cm ² / 50 g | LCD Driver (item 2.4 in the picture) |
| | 46 cm ² / 40 g | PCB Backlight Stabilization (item 2.5 in the picture) |
| | 71 cm ² / 80 g | PCB Touch-Screen controller (item 2.6 in the picture) |
| | 40 cm ² / 50 g | PCB Touch-Screen (item 2.7 in the picture) |
