<b>PHILIPS HEALTHCARE</b>	<b>Product Recycling Passport</b>	Page 1 of 3
-------------------------------	-----------------------------------	-------------

<b>Product name:</b>	<b>ClearVue 650 Medical Diagnostic Ultrasound Equipment</b>	
<b>Identification code(s)</b>	<b>989605414681</b>	
<b>Total weight (in Kg)</b>	<b>56.43 kg</b>	
<b>Producer/ Manufacturer</b>	<b>Name company:</b>	Philips Ultrasound
	<b>Address:</b>	22100 Bothell Everett Highway, Bothell, WA
	<b>Zip code:</b>	98012
	<b>Country:</b>	USA

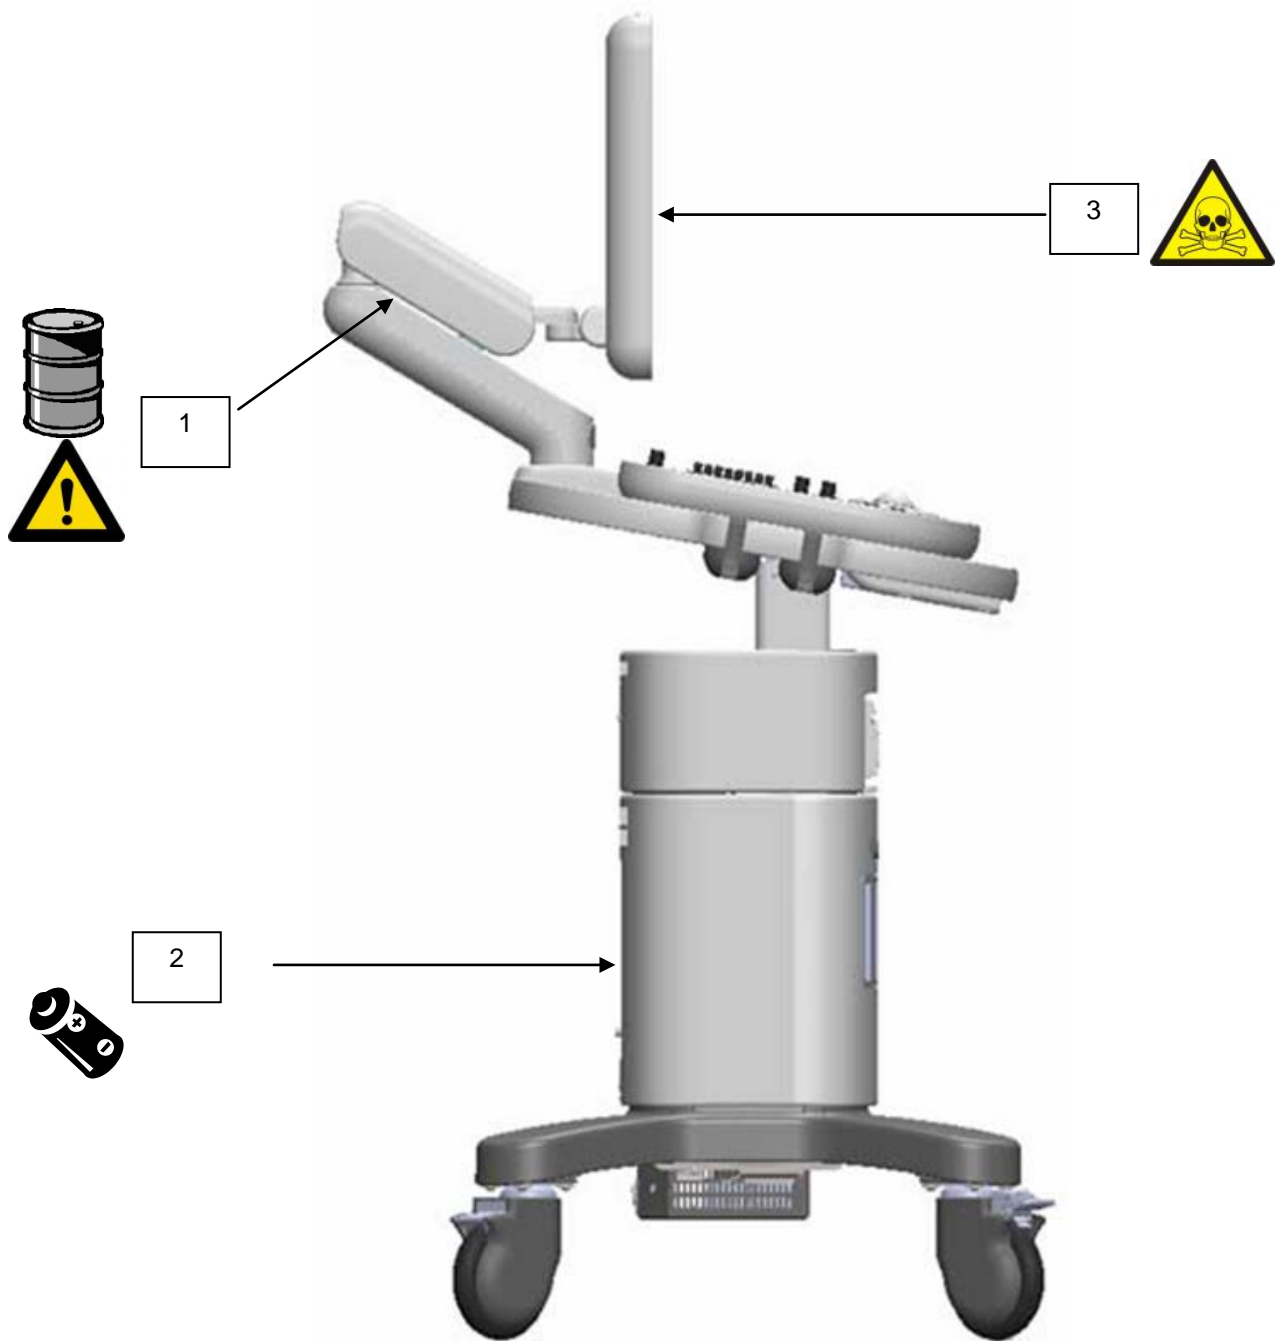
Figure 1: ClearVue 650

Gas strut under pressure	Figure 1 [1]

<b>Fluids / Gases</b>	Oil and Nitrogen gas: in gas strut in Articulation Arm mechanism. Do not drain oil with device under pressure	Figure 1 [1]

<b>To be Removed</b>	Battery in System. Button cell on Motherboard.	Figure 1 [2]

<b>To be Removed</b>	Mercury (Hg) – Monitor contains mercury in the backlight lamps.	Figure 1 [3]

Show locations of materials mentioned on the previous sheet. (Picture information)
